Manhole Inspection Summary

Manhole # S35SS1018MH

Insp Date: **4/2/07 2:16 PM**

Location Address: **5118 NORWOOD RD**

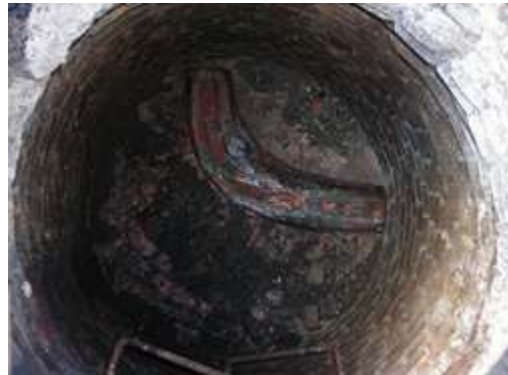
Top View

Bench debris.

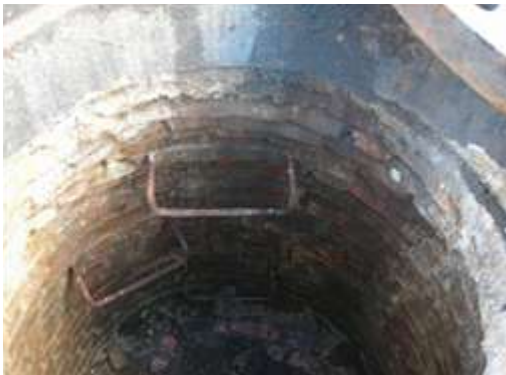
Defect

Frame leaks. Frame offset. Adjustment and Barrel infiltration - other side.

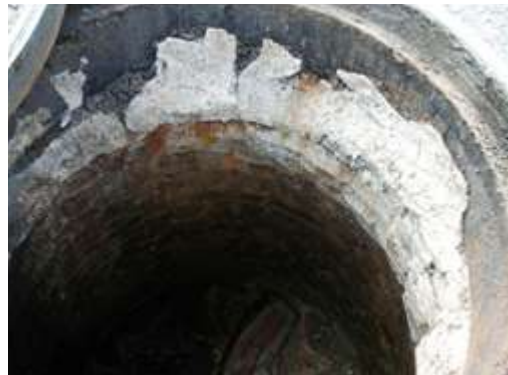
Defect

Frame leaks. Frame offset. Adjustment and Barrel infiltration.

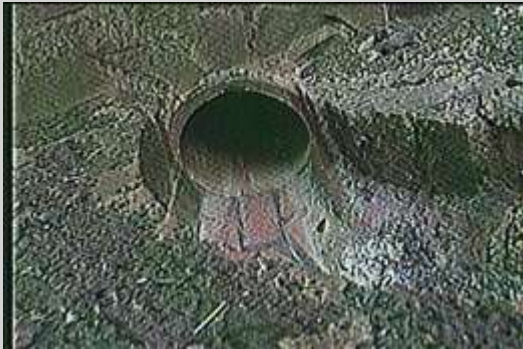
Pipe Out @ 12 O'Clock

Infiltration: **None** Pipe Seal Cond: **Unknown**

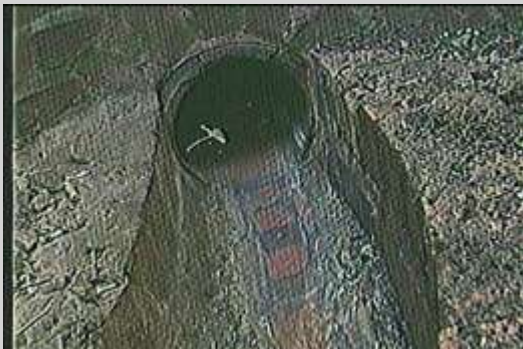
Pipe In @ 3 O'Clock

Infiltration: **Evidence** Pipe Seal Cond: **Cracked**
